OPEN FRAME PUNCH LIST

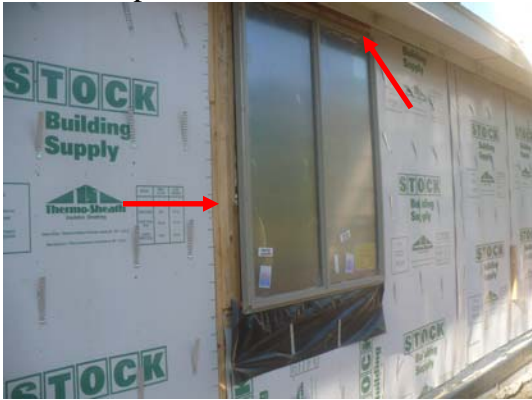
- 1) The right elevation bathroom window is not properly installed on the left side. The top brick frieze and bitumen should also be installed.

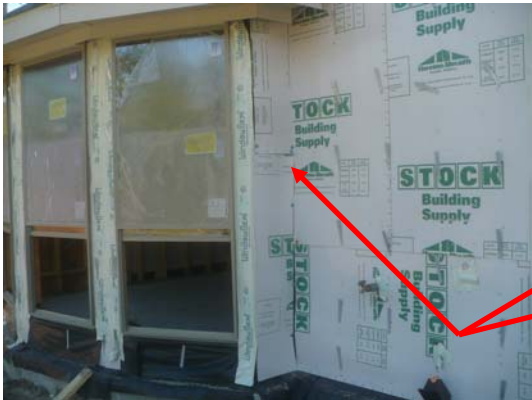
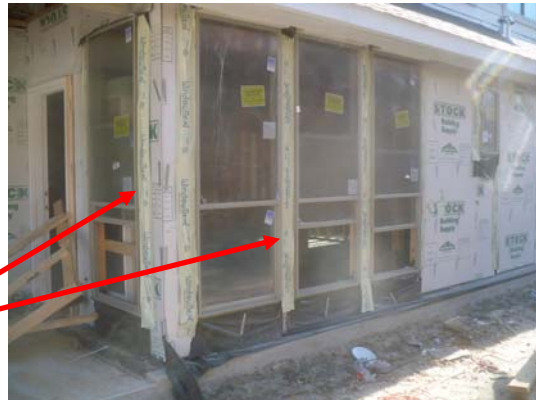
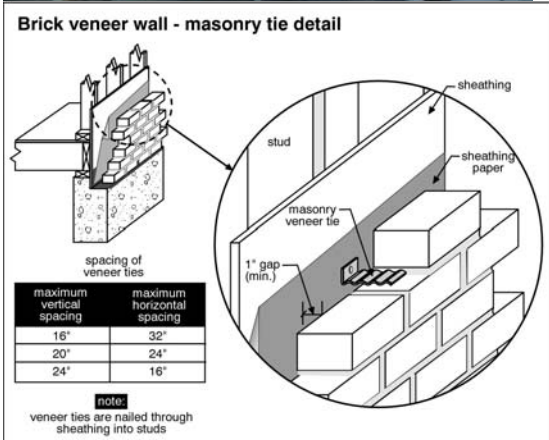
- 2) Brick ties should be installed at the rear inside corner and around all the rear elevation windows.

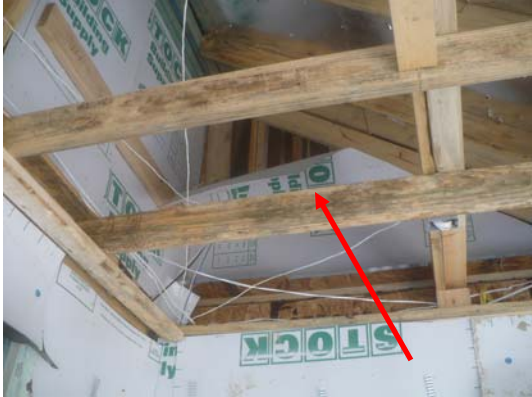
- 3) Re-secure the thermo-ply above the rear patio.

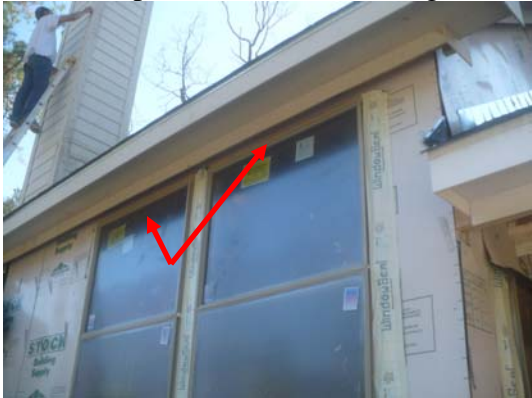
4) The top brick frieze is missing over the rear living room windows.

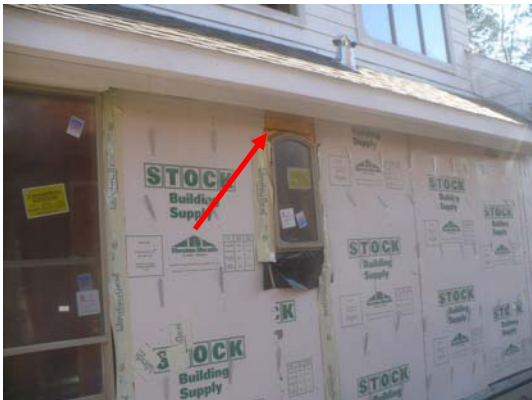
5) Thermo-ply and bitumen should be installed above the right elevation arch window.

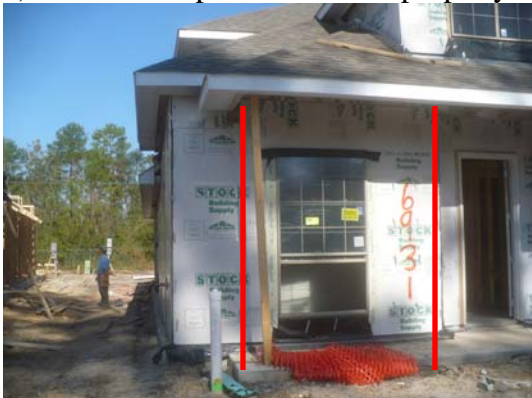
6) Permanent posts should be properly installed under the front porch beam.

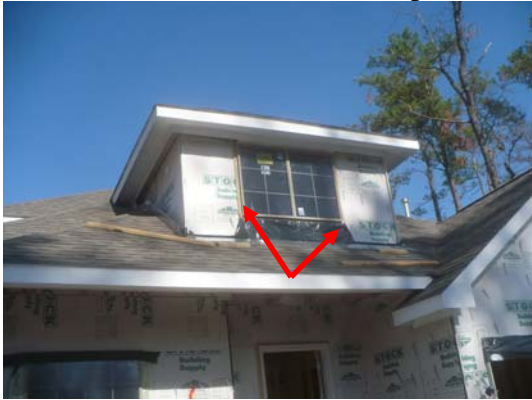
7) Install bitumen window wrap around the upstairs front window.

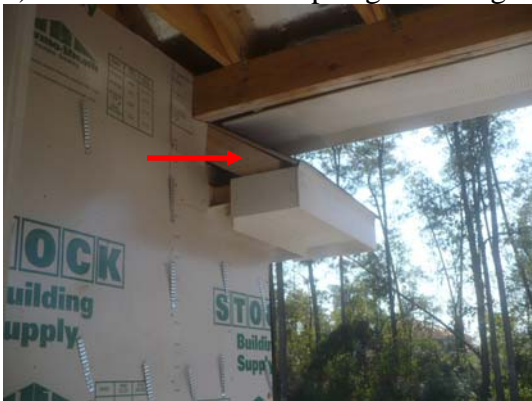
8) Fascia board and drip edge flashing missing at the front porch garage roof return.

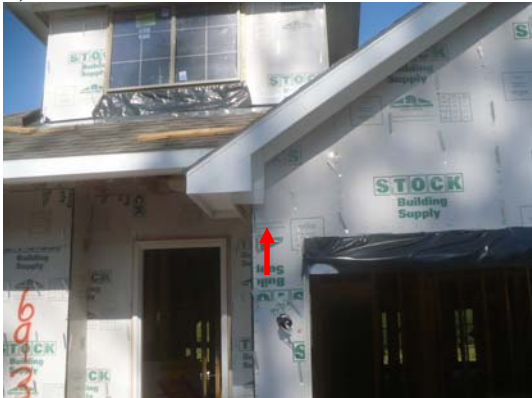
9) The brick frieze on the left side of the garage gable is out of level.

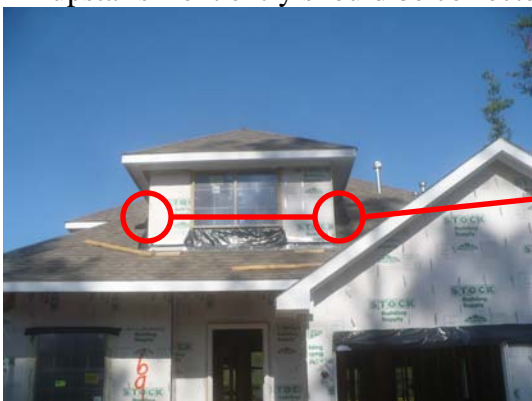
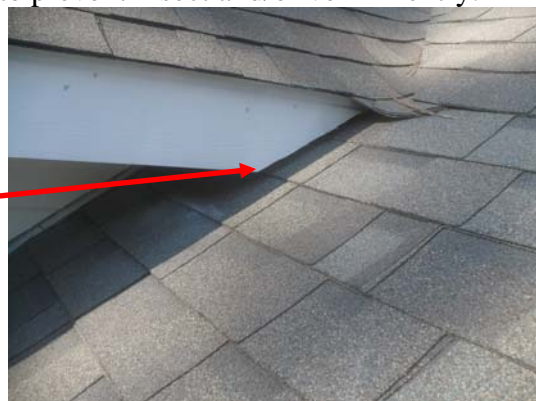
10) Excessive gaps between roof covering and soffit/fascia on each side of the upstairs front entry should be corrected to prevent insect and/or vermin entry.

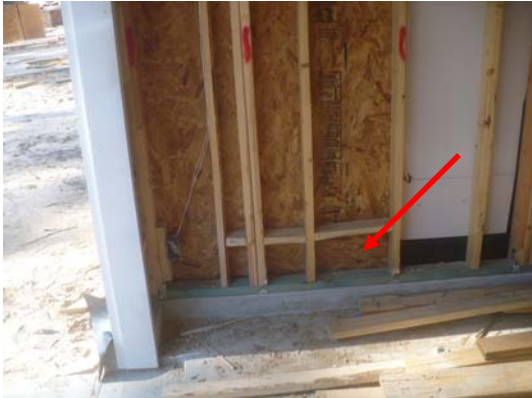
- 1) The bottom panel of OSB sheathing on the left side of the garage should be secured.

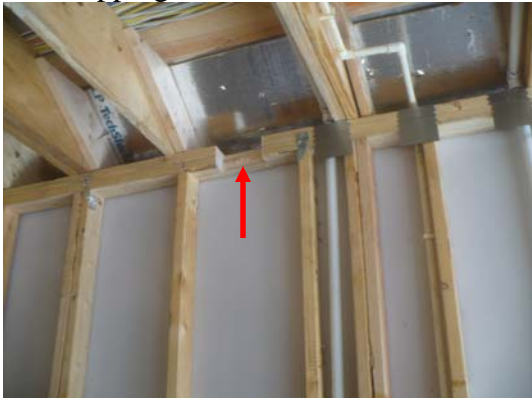
- 2) The large notch in the right elevation garage wall should be reinforced with steel strapping.

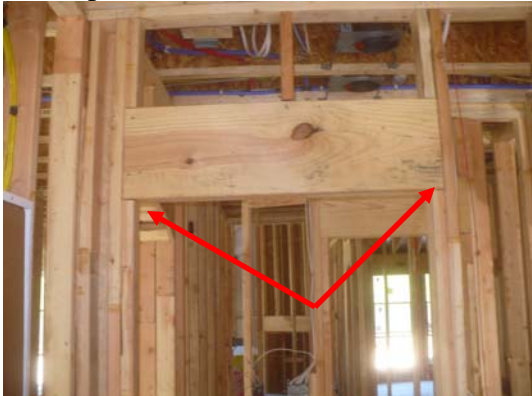
- 3) Gaps between the bottom of the headers and cripples should be shimmed.

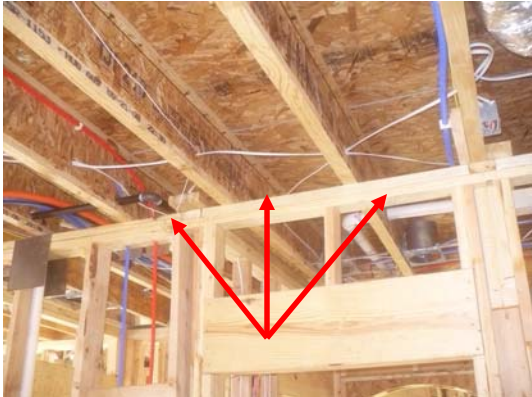
- 4) Anti-racking blocks (or panel blocks) should be installed between the trusses per manufacturer's recommendations.

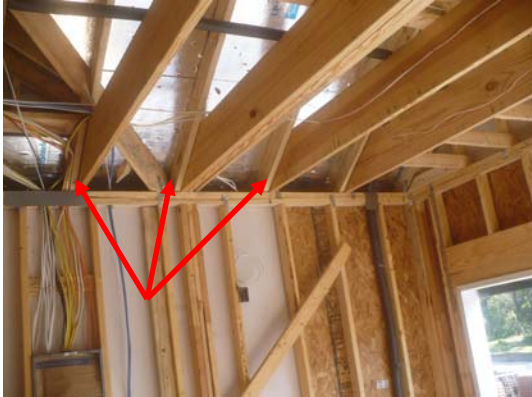
5) Hurricane strapping should be added to the right elevation rafters.

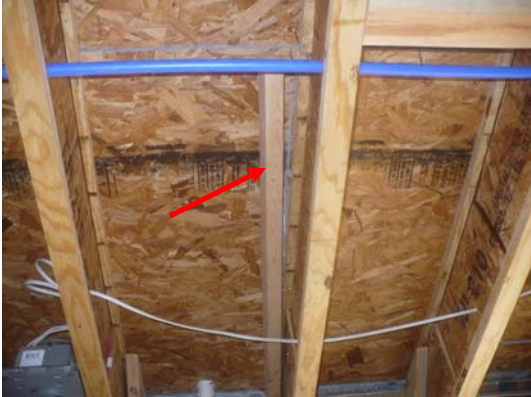
6) The nailer block for the upstairs decking is loose above the master bathroom.

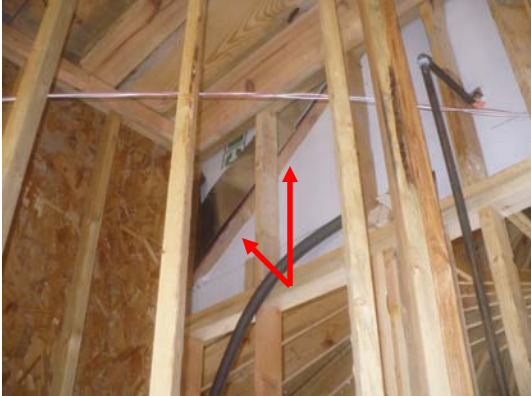
7) Two fireblocks should be installed along the rafter in the fireplace chase.

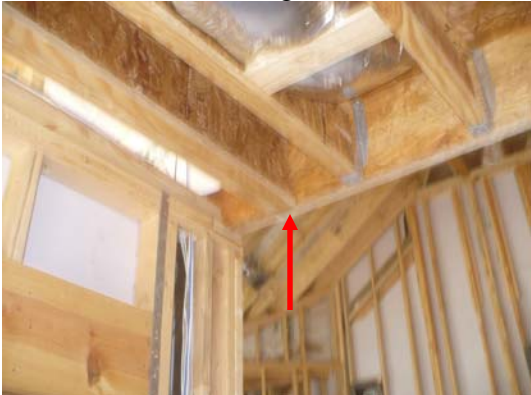
8) A Double TJI hanger should be installed on the floor joists above the rear door.

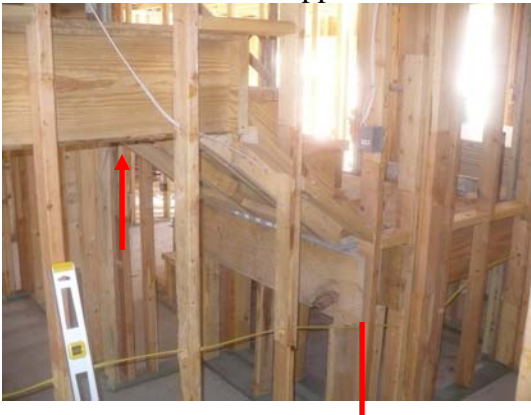
9) Missing a fireblock on the second staircase landing and the 2x riser should have a stud installed for support.

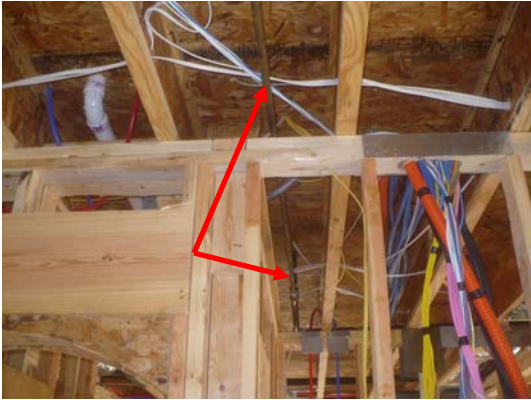
10) Correct the electrical wires in contact with the gas line above the laundry room.

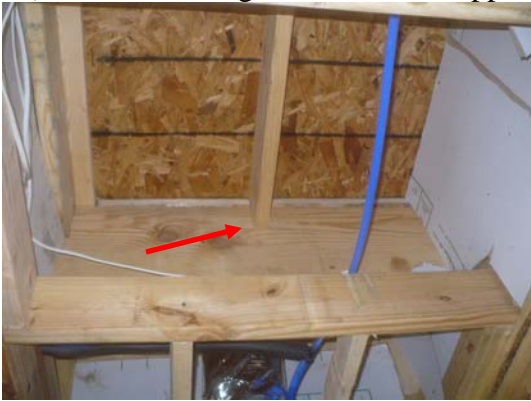
11) Add metal hangers on the 2x6 supporting the staircase niche.

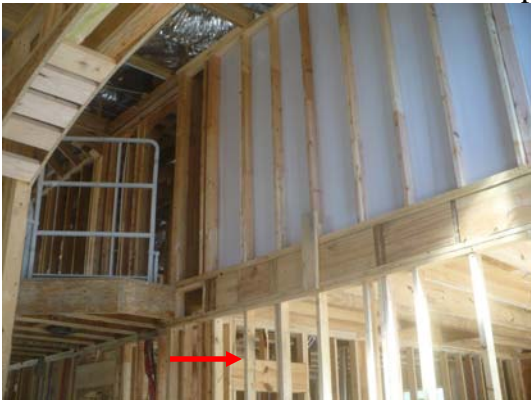
12) Double studs should be under beams and all the way to the ground. One more stud should be added downstairs for the upstairs entry beam.

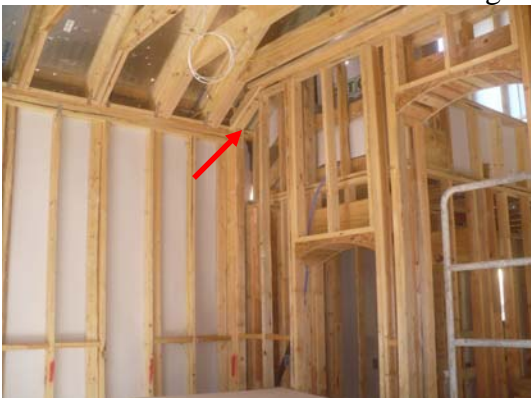
13) Studs should be added in the knee wall under the left elevation triple 2x6 rafters at the left inside corner of the dining room.

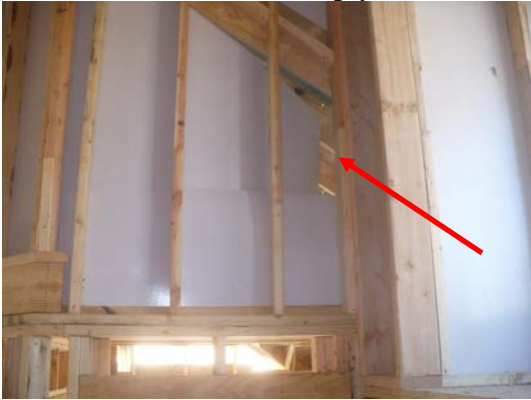
14) Re-secure the thermo-ply at staircase.

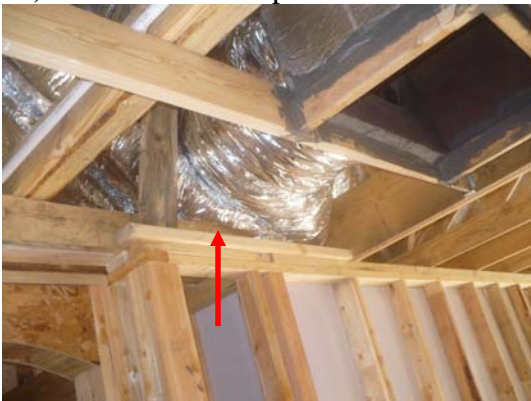
15) The air ducts are pinched above the entry of the upstairs front bedroom.

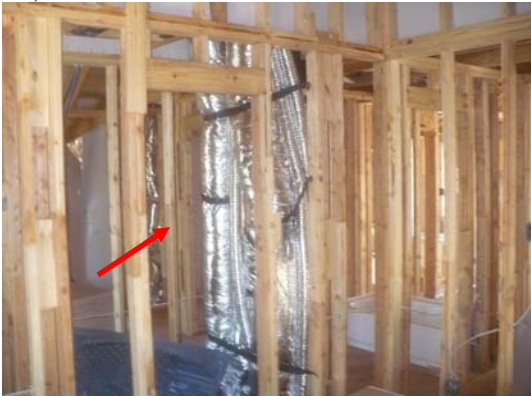
16) A chase wall will have to be constructed in the upstairs rear bedroom closet.

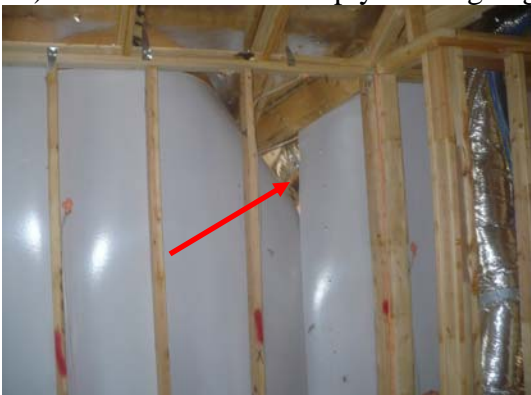
17) Re-secure the thermo-ply above garage (upstairs front bedroom).

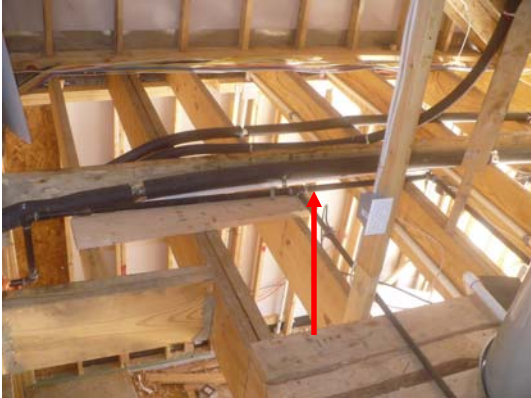
18) The downstairs a/c unit primary drain line has inadequate slope and should be corrected.

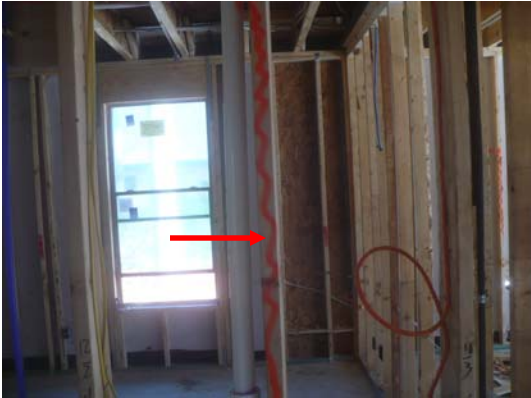
19) Bowed studs at various locations have been marked with orange paint.
