# PROPERTY INSPECTION REPORT

**Prepared for: Client's Name**

**Concerning: 123 Anystreet, Houston, TX**

**Date: 05/05/2006**

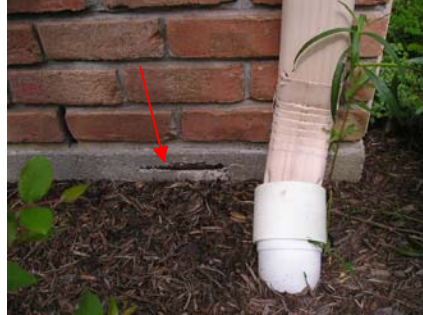
- Foundation: Post tension cable or rebar ends were observed on the exterior of the foundation. If left unattended, the cable can rust and compromise foundation integrity. Minor repair(s) should be undertaken as necessary to prevent corrosion. NOTE: A non-shrink cement mix should be used.

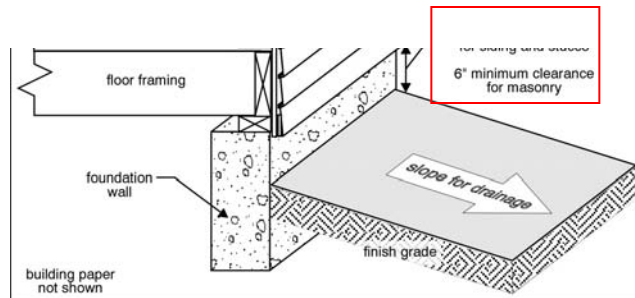
- Outside of Building: At least four (4) to eight (8) inches of clearance should be maintained between soil level and the top of the foundation walls.

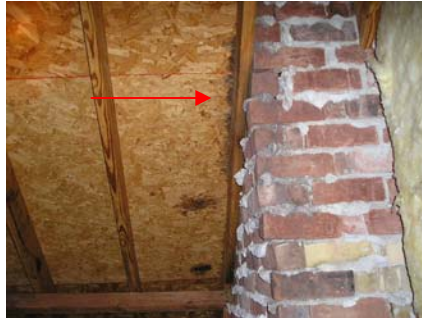
- Attic: Signs of water staining were noted on framing members or decking, indicating previous leakage (chimney). Further investigation as to whether the leaks are active and to the amount of damage may be necessary.

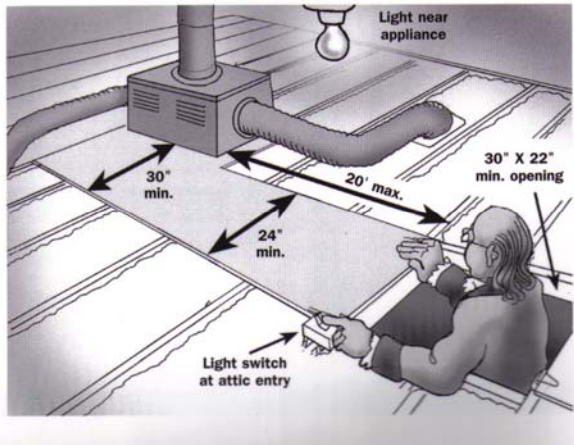
Fig. 4 • Attic Furnace

- Attic: A minimum 2 feet wide pathway should be provided to appliances for servicing and removal.

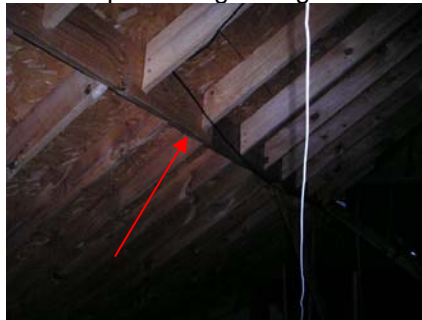
- Attic: Spliced ridge at right rear attic should be supported.

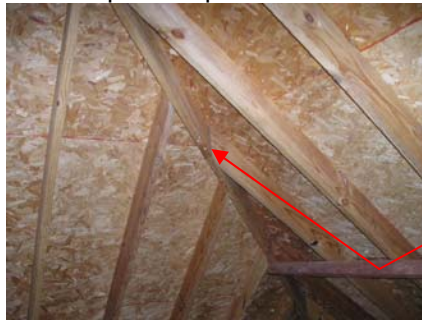
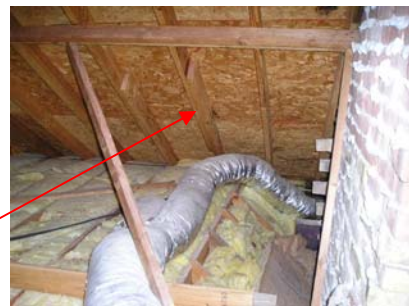
- Attic: Spliced hip and rafters in the left rear attic should be supported by braces.

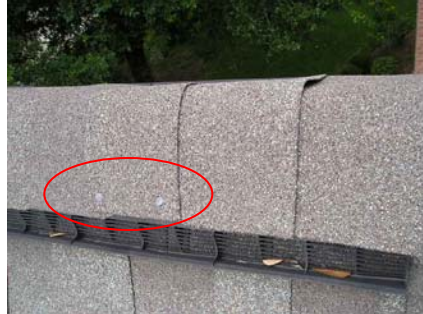
- Roof: Nail heads are exposed at various areas of the roof. They should be sealed to reduce risk of leaks.

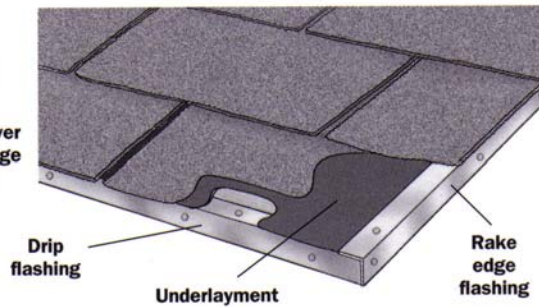
**Fig. 47**  
**Roof Edge Flashing**

- Roof: The underlayment (felt paper) of the roof covering is not properly installed. The felt should be installed over the drip edge (roof flashing) at the eaves with no nails penetrating the felt. It is standard and acceptable, however, to install felt under the drip edge at the rake (slope of roof). A qualified roofer should be consulted and improvements made as recommended by the manufacturers installation instructions and / or to the Asphalt Roofing Manufacture Associations` (ARMA) industry standards.

Underlayment laps over drip flashing, rake edge flashing laps over underlayment

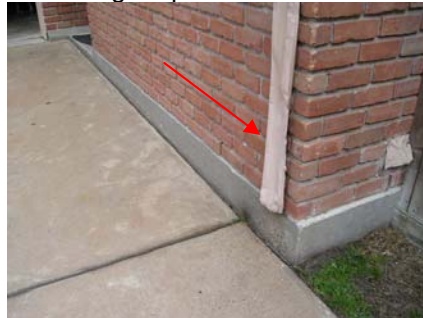
- Outside of Building: Loose or damaged gutters and downspouts should be repaired or replaced as necessary to avoid spilling roof runoff around the building - a potential source of water entry or water damage.

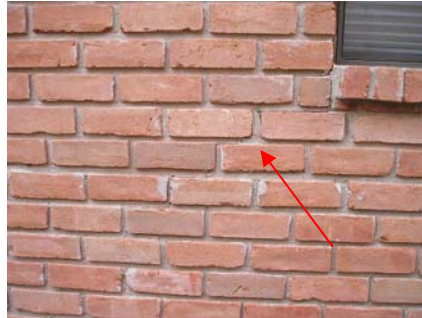
- Outside of Building: Observed a smaller diagonal crack in the left elevation brick (apparently caused from lack of expansion joint). This area should be monitored in the future.

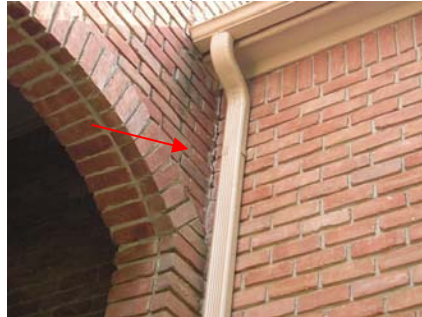
- Outside of Building: The brick mortar is in need of improvement at various locations. A qualified mason should be engaged.

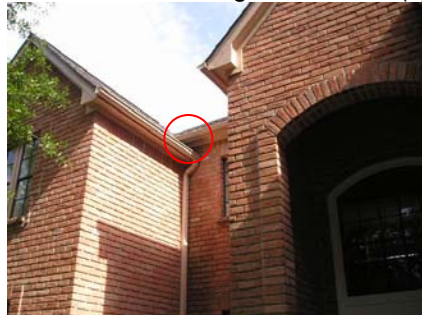
- Outside of Building: Loose brick(s) at the front elevation should be re-secured.

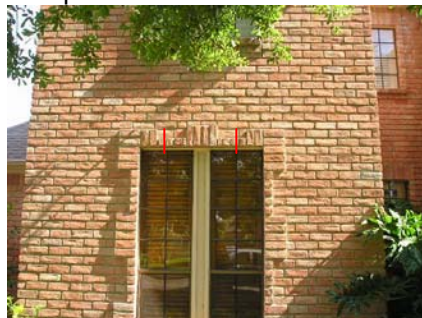
- Outside of Building: LINTEL: Weep holes (openings in the mortar joints, typically found at foundation level and above doors and windows to allow trapped moisture to escape) were not found in the brick veneer wall above a lintel (in effect, a beam supporting the brickwork above an opening in the wall). Improvements are recommended.

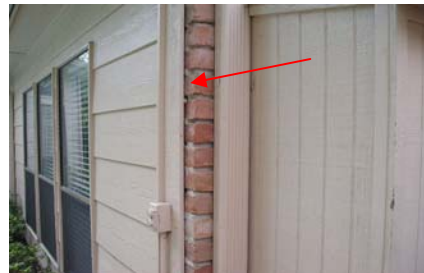
- Outside of Building: Brick frieze at left rear elevation should be sealed against brick veneer.

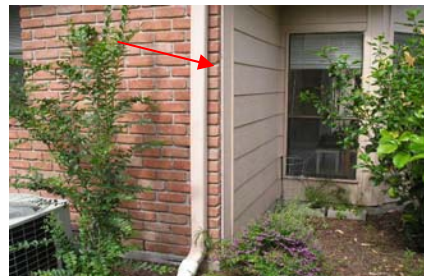
- Outside of Building: Brick frieze should be sealed against brick veneer at right rear elevation.

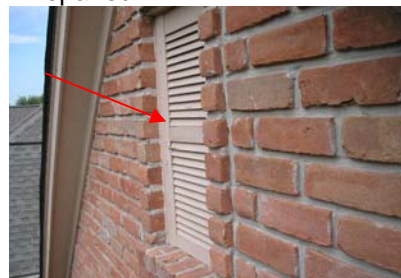
- Outside of Building: A front gable louver has some wood rot that should be repaired.

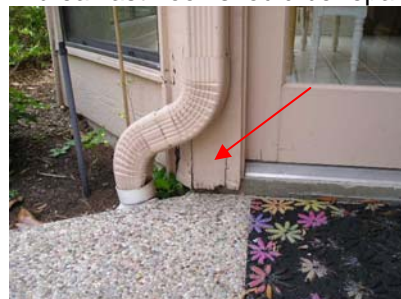
- Outside of Building: Rotted or deteriorated wood trim at rear elevation outside breakfast nook should be repaired.

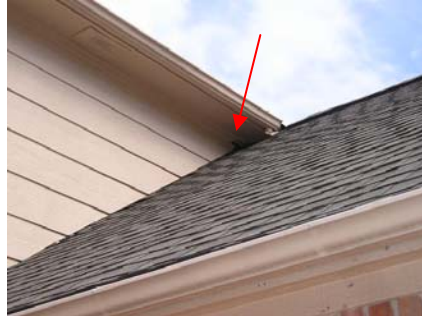
- Outside of Building: Chewed or damaged siding and trim above kitchen roof (right side of garage wall) should be repaired as needed.

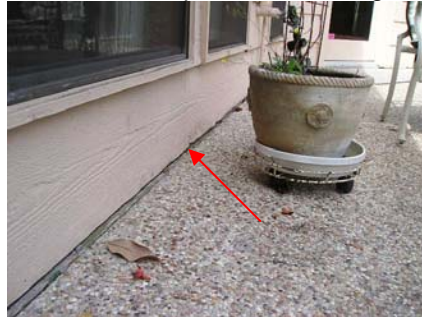
- Outside of Building: This particular type of wood fiber or laminate siding may be prone premature decomposition due to moisture related problems. Further evaluation in to the brand and its current status is recommended. Decayed or deteriorated portions of siding should be replaced as necessary.

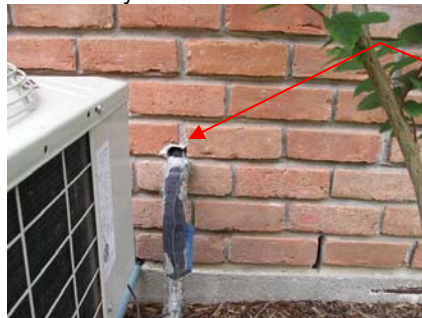
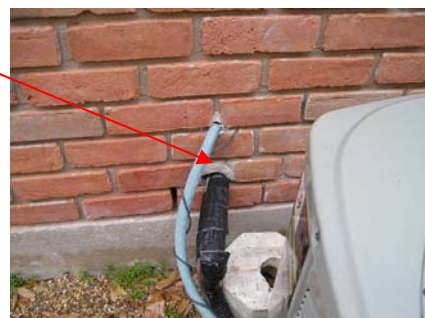
- Outside of Building: Any holes, gaps or other penetrations (i.e. where AC suction line(s) enter wall cavity, soffit / trim details, mortar joints in brick, et. al) should be repaired / sealed as necessary to prevent leaks, drafts or vermin entry. However, weep holes should be left open in the bottom row of brick in masonry veneer.

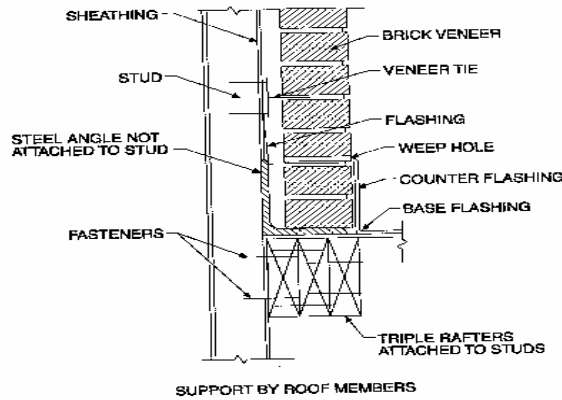
FIGURE R703.7.2.2  
EXTERIOR MASONRY VENEER SUPPORT BY ROOF MEMBERS

- Outside of Building: Brick supported by the roof at the front elevation does not appear to be properly supported. The lintel (in effect, a beam supporting the brickwork above an opening in the wall) and / or masonry veneer above do not appear to be properly installed and should be further investigated and repaired as necessary. Current standards suggest: A minimum 6 x 4 x 5/16 steel angle, with the long leg placed vertically, shall be anchored to double 2" x 4" wood studs at a maximum on center spacing of 16". Anchorage of the steel angle at every double stud spacing shall be a minimum of two 7/16"-diameter by 4-inches lag screws. The steel angle shall have a minimum clearance to underlying construction of 1/16 inch. A minimum of two-thirds the width of the masonry veneer thickness shall bear on the steel angle. Flashing and weep holes shall be located in the masonry veneer wythe. The maximum height above masonry veneer above the steel angle support shall be 12` 8".

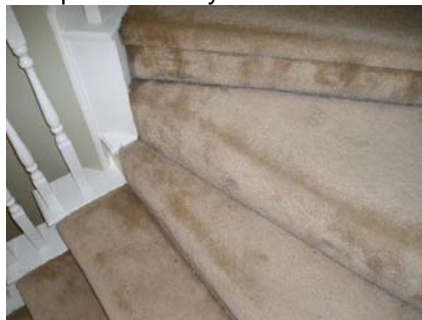
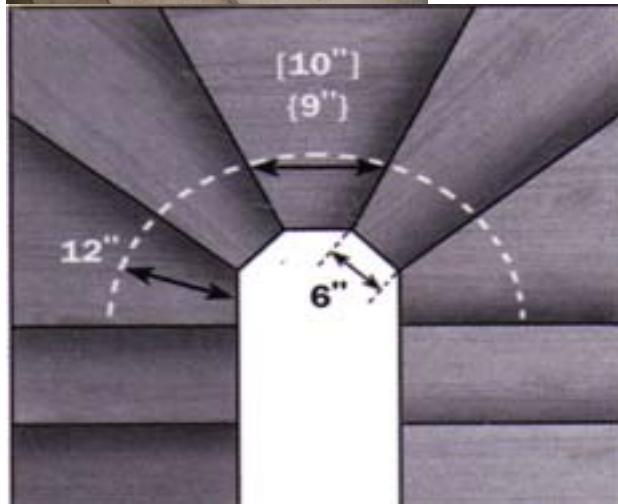
- Interior: Floor squeaks were observed at various locations in the upstairs flooring that should be repaired as needed by a qualified contractor.
- Interior: The size and/or orientation of the stairway "treads" and / or "risers" may make the stairway difficult to negotiate. This condition should be altered for improved safety.

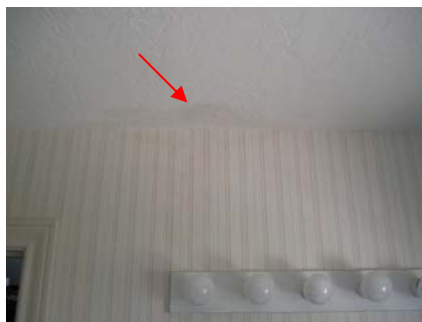
- Bathroom(s): Staining was noted in the upstairs right rear bathroom sink area (no active moisture). The cause for the staining should be determined and repairs undertaken, if necessary, to prevent structural damage.

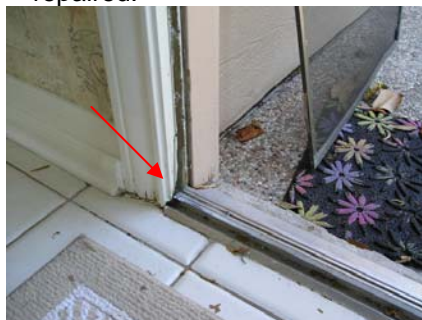
- General: Trim rot was noted around the breakfast nook door and should be repaired.

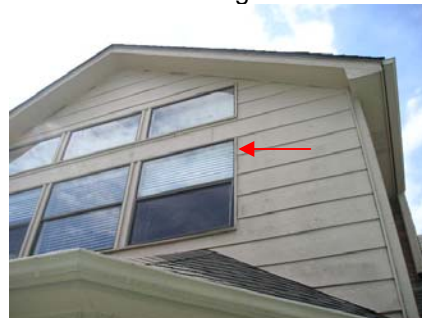
- Outside of Building: An upstairs rear elevation window is broken and should be replaced.
- Outside of Building: Rotted or deteriorated window trim should be repaired.

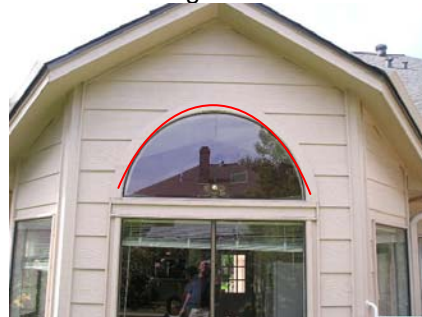
- Outside of Building: The arch window and trim at rear elevation should have a metal flashing installed above to prevent moisture damage.

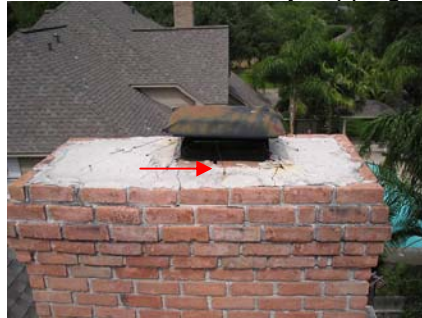
- Roof: Cracked chimney capping should be repaired.

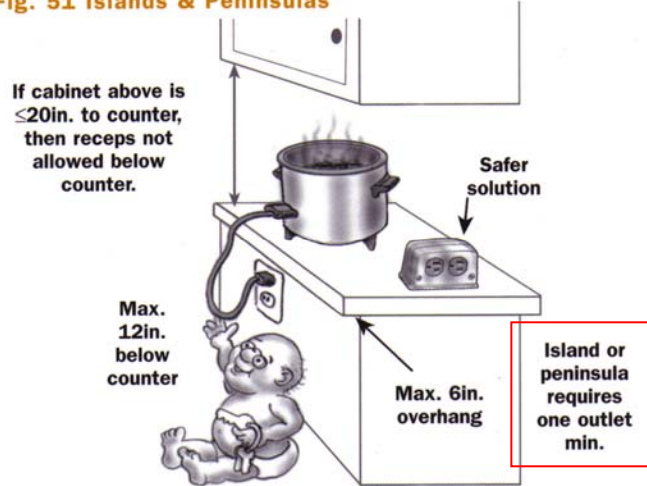
**Fig. 51 Islands & Peninsulas**

- Outside of Building: A ground fault circuit interrupter (GFCI) outlet did not respond correctly to testing during the inspection (left rear elevation). This receptacle should be replaced.
- Outside of Building: The front porch outlet has been wired backwards and will not respond correctly to GFCI test. Recommend further evaluation and repair by a qualified electrician.
- Interior: The 220v dryer outlet does not appear to have power. Recommend further evaluation by a qualified electrician.
- Kitchen: Kitchen island is required to have a minimum one GFCI electrical outlet. Recommend repair by a qualified electrician.

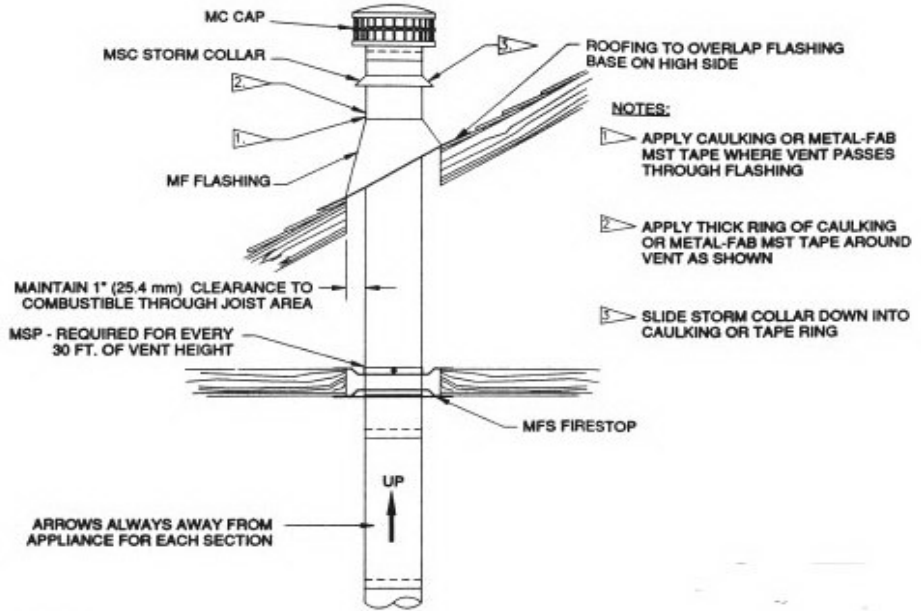
- Unit 2: The flame was observed to be slightly yellow in color. The flame should be sharp and blue. This is an indication of incomplete combustion. Further evaluation is recommended.
- Unit 2: Rust and/or debris were noted in the burner compartment. The unit should be serviced by a qualified HVAC professional. **Replacement may be necessary.**
- General: The current installation of the flue pipe is not acceptable by today's standards. The vent terminates inside the vent cap. The pipe should extend through the roof flashing, roof jack or thimble and terminate by a listed termination cap. This is a safety hazard and should be repaired.

- General: The current installation of the flue pipe is not acceptable by today's standards. The vent terminates inside the vent cap. The pipe should extend through the roof flashing, roof jack or thimble and terminate by a listed termination cap. This is a safety hazard and should be repaired.

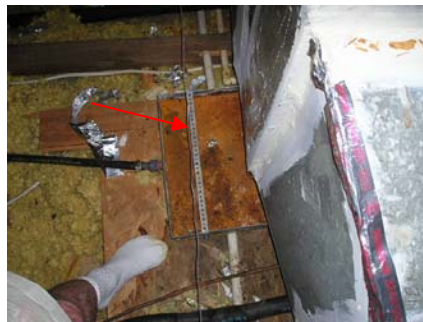
- Outside of Building: No electrical disconnect was provided for the outdoor cooling system(s). Current standards require a disconnect to be within sight of the unit. Improvements are recommended.
- Unit 2: Rust and/or debris were noted in the drain pan and should be cleaned.

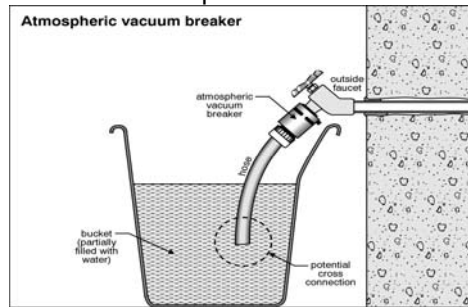
- Outside of Building: It is recommended that an anti-siphon device be added to the hose bib(s). This is a small device that attaches to the outside hose connection to prevent water contamination.
