OPEN FRAME PUNCH LIST

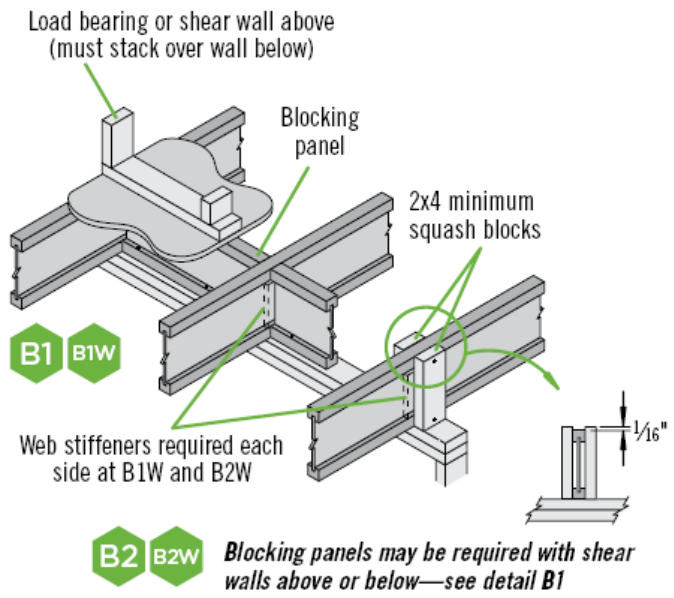
FLOOR DETAILS

- 4) Anti-racking blocks (or panel blocks) should be installed between the trusses per manufacturer's recommendations.
